Fuel Leak Simulation

**Dr. Michael R. Swain
University of Miami
Coral Gables, FL 33124**

Abstract

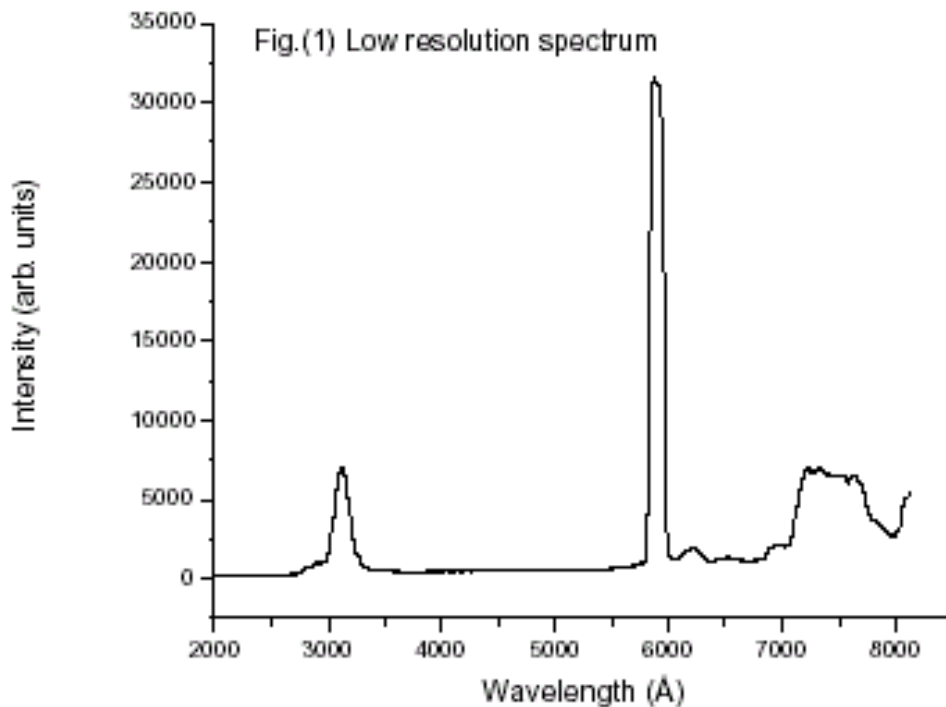
Figure (1) shows a typical low-resolution spectrum of the flame and is not corrected for the spectral response of the spectrograph and diode array. It is clear however, that three features dominate the spectrum:

- 1) a broad peak in the ultraviolet at ~ 3000 Å.
- 2) a narrow peak at ~ 5890 Å.
- 3) a broad peak in the near infrared between 7000-8000 Å.

There is an additional signal that lies above the background noise. Its integrated intensity is small compared with the main features and no clear spectral signature can be identified at this spectral resolution.

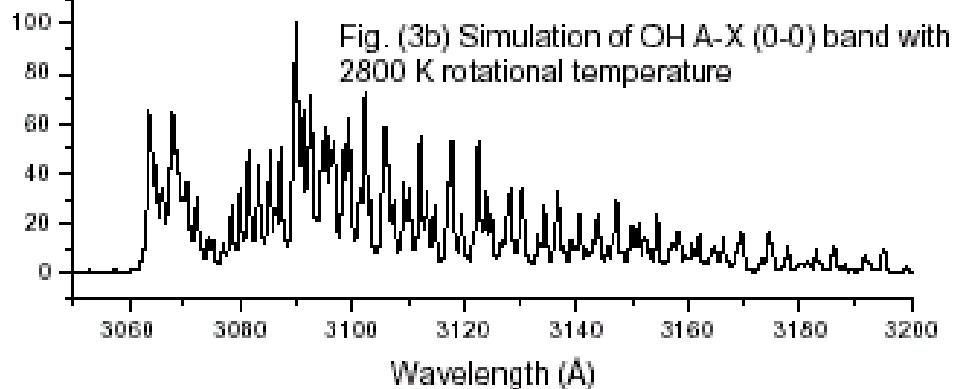
Figure (3a) shows a high-resolution spectrum of a portion of the 3000 Å feature. It can be seen that, in contrast to the sodium D lines we have a complex multi-line spectrum. This is characteristic of the spectrum of a simple diatomic or polyatomic molecule and the relatively open structure suggests a hydride. The strong emission spectrum of the OH A $^2\Sigma - X^2D$ (0-0) band lies in this region. This emission is characteristic of H_2/O_2 flames and has been extensively observed and characterized. A quantitative identification requires a computer simulation of the spectrum. Figure (3b) shows a simulation of the OH A-X (0-0) emission spectrum assuming a rotational temperature of 2800 K and a spectral resolution of 0.6 Å. The simulation clearly identifies the experimental feature as being due to OH. We have not attempted to identify the broad infrared spectral feature. Several sets of high and low-resolution spectra were obtained and this involved relighting the flame several times. It is an extremely turbulent diffusion flame

but nevertheless the degree of reproducibility of both the low and high-resolution spectra was remarkable.

These results demonstrate that the dominant spectral feature in the visible region of the spectrum is due to sodium D line emission. This is due to particulate matter containing sodium that is entrained into the flame. The results also demonstrate that we can obtain high-resolution spectra of the OH radical, which may serve as an important flame diagnostic particularly of flame temperature. If the sodium emission is due primarily to thermal excitation, then the brightness of the sodium D line emission will depend on the diffusion flame temperature.

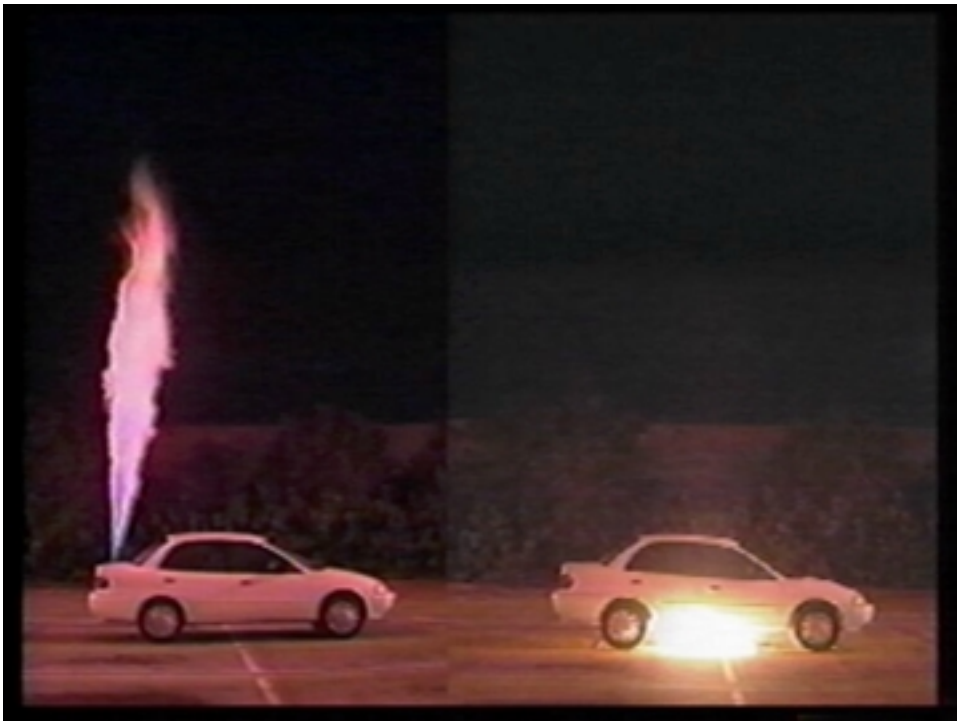
Photo 2 - Time 0 min, 3 seconds - Ignition of both fuels occur. Hydrogen flow rate 2100 SCFM. Gasoline flow rate 680 cc/min.

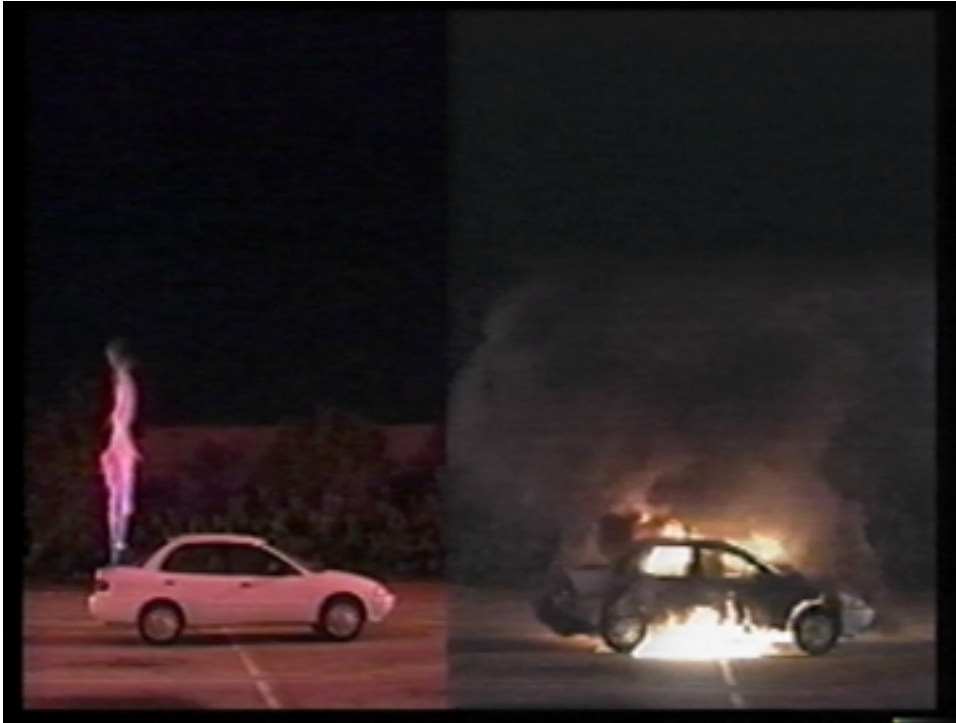
Photo 3 - Time: 1 min, 0 sec - Hydrogen flow is subsiding, view of gasoline vehicle begins to enlarge

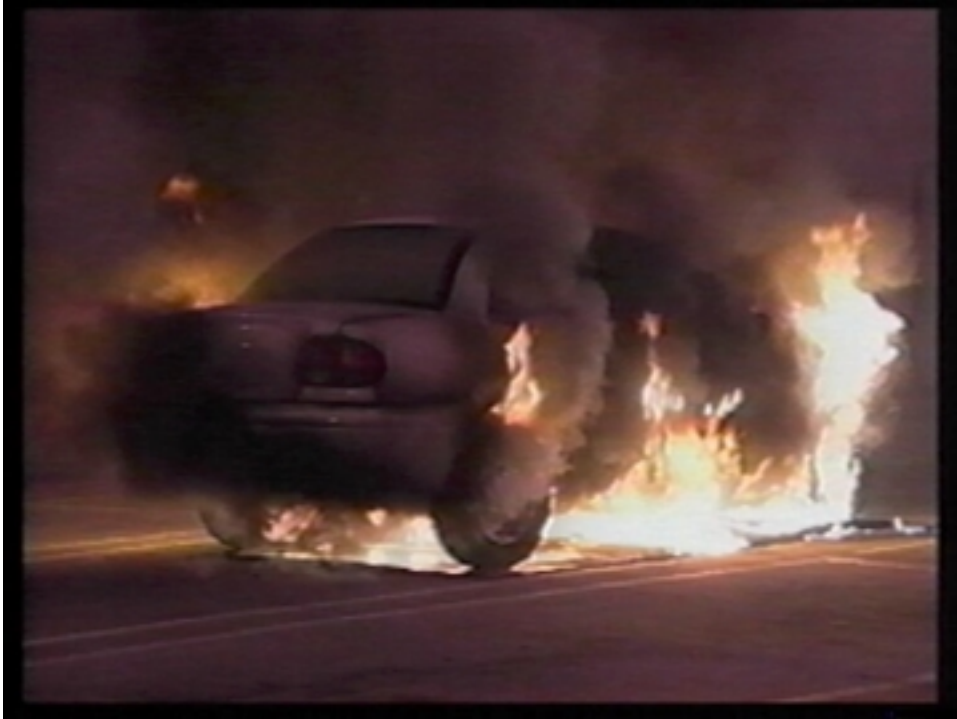
Photo 5 - Time: 2 min, 20 sec - Frame prior to interior deflagration.

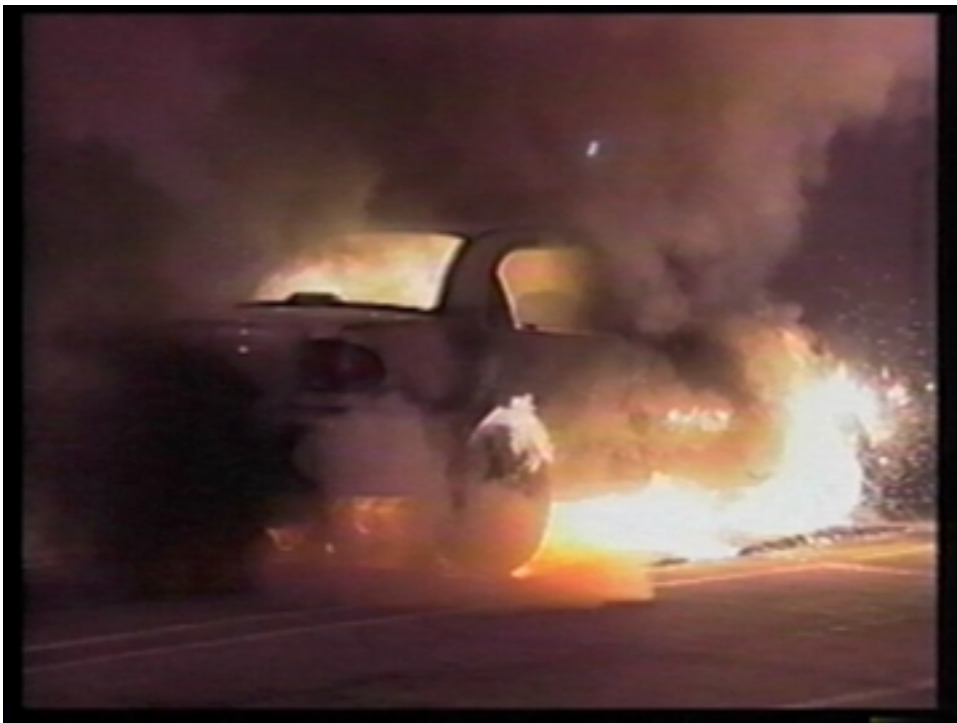
Photo 6 - Time: 2 min, 20 sec - Deflagration in the interior, following frame shows flames exiting around edges of trunk lid.

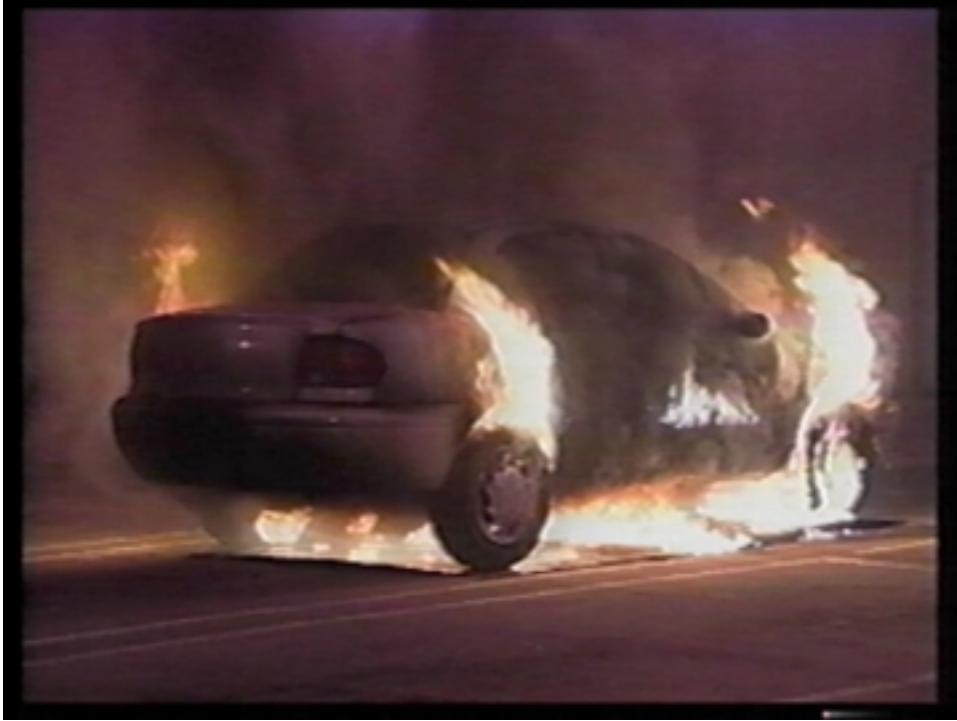
Photo 7 - Time: 2 min, 40 sec - Frame prior to driver's side rear tire rupture.

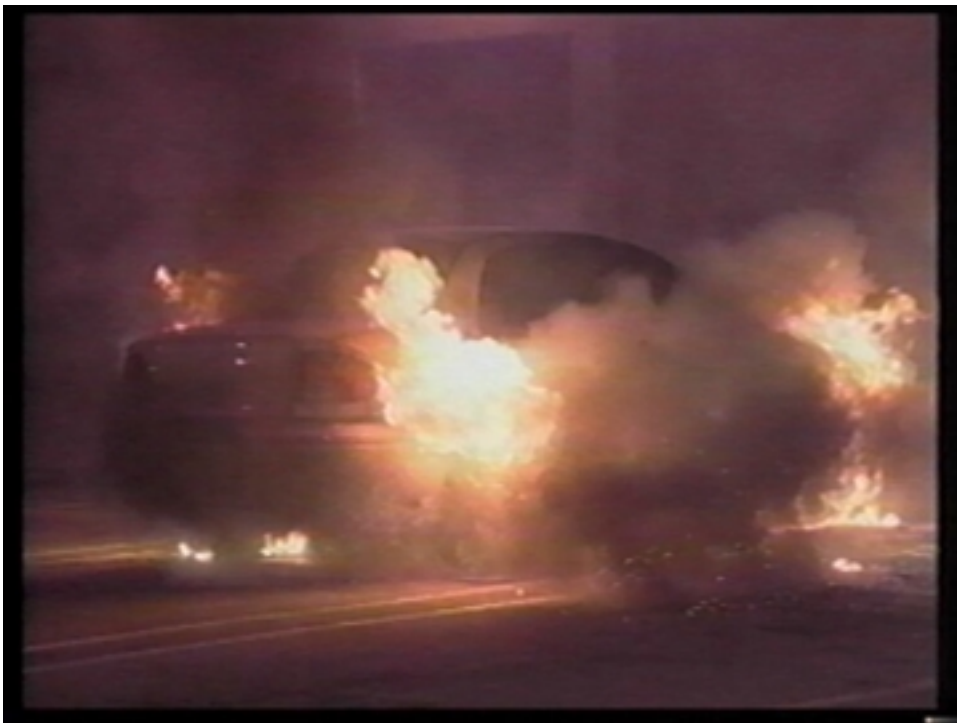
Photo 8 - Time: 2 min, 40 sec - Driver's side rear tire rupture sends debris out the passenger side of the vehicle.
